NITRATE VILLAGE NO.1 LOCAL HISTORIC DISTRICT

DESIGN REVIEW GUIDELINES

Historic Sheffield Commission

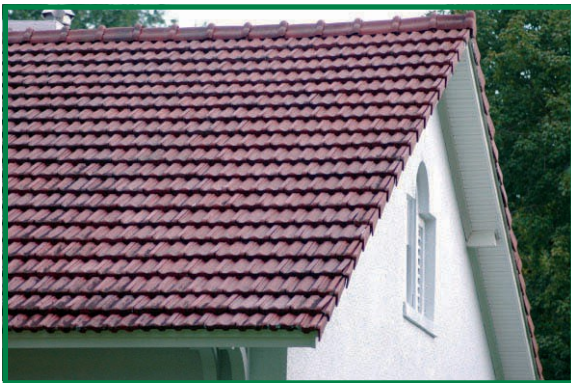
Note how the material and form of this historic clay tile roof is an integral element of the design, character of the house. Both the roof's form and its

material are significant features.

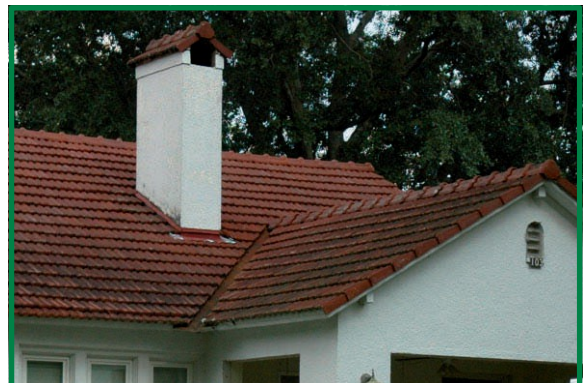
Note how the ridge caps, valley design and materials, and the chimney design contribute to the historic character of this roof.

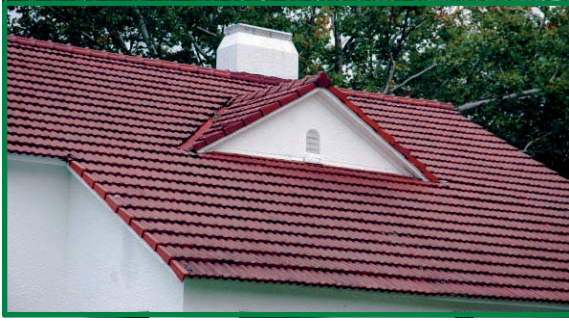
Note the contributing gable dormer with its round arched louvered vent and the thin and simple cornice.

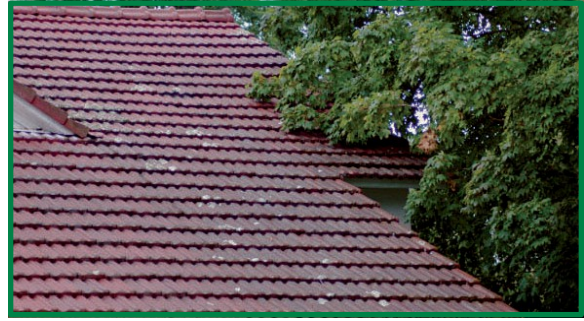
Trees should be pruned to prevent damage to historic roof tiles.

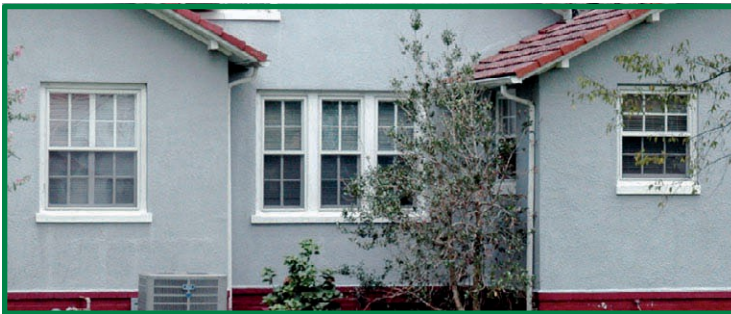
Note the variety of windows on this house: double 4/4-light at left, triple 4/4-light at center, and single 6/6 at right. The size, pane configuration, and details of windows are a major character-defining feature of historic buildings.

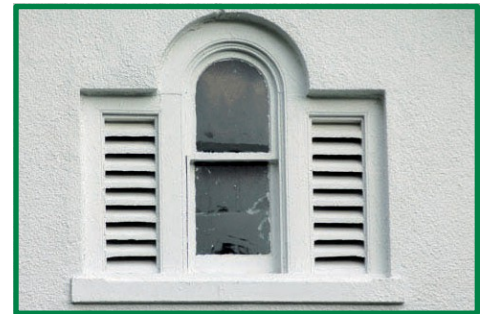
Note specialty Palladian window arrangement with arched center 1/1 light sash flanked by louvers.

c. *Palladian Windows*. Historic Palladian windows should be retained and repaired as needed to match documented historic conditions. Where such features do not presently exist, their installation at principal elevations is not appropriate unless they are being installed to match documented historic conditions.

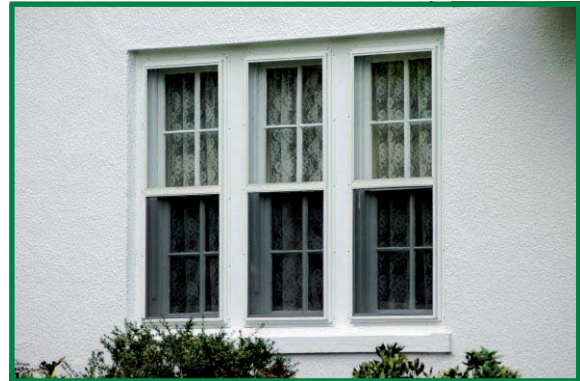
Note how the dividing rails of these storm windows meet the dividing rails of the historic window. The minimal framing is finished to match the adjacent window trim. The result is a storm window that has minimal visual impact on the historic window.

e. *Screen/Storm Windows*. Historic screen windows should be retained and repaired as needed. The use of interior storm windows is recommended, especially at principal elevations. Exterior storm windows are appropriate as long as they meet the following characteristics: 1) framing members are minimal in width and profile; 2) any horizontal bracing or other divisions line up visually with the meeting rails of the underlying window sash; and 3) the framing is finished to blend in or match the surrounding trim color. Storm windows should also allow for ventilation along their bottom edge to allow condensation to evaporate. Exterior screens should follow the same general guidelines for storm windows. Screen/storm windows should be installed without removing, damaging, or obscuring character-defining architectural features or trim and installed in such a manner as to be removable in the future without destroying architectural features.
